New York State Department of Transportation

Yellow Flag NB23U4W015

BIN: 1065318

Location: Span 256, Stringer S1 at Pier 255.

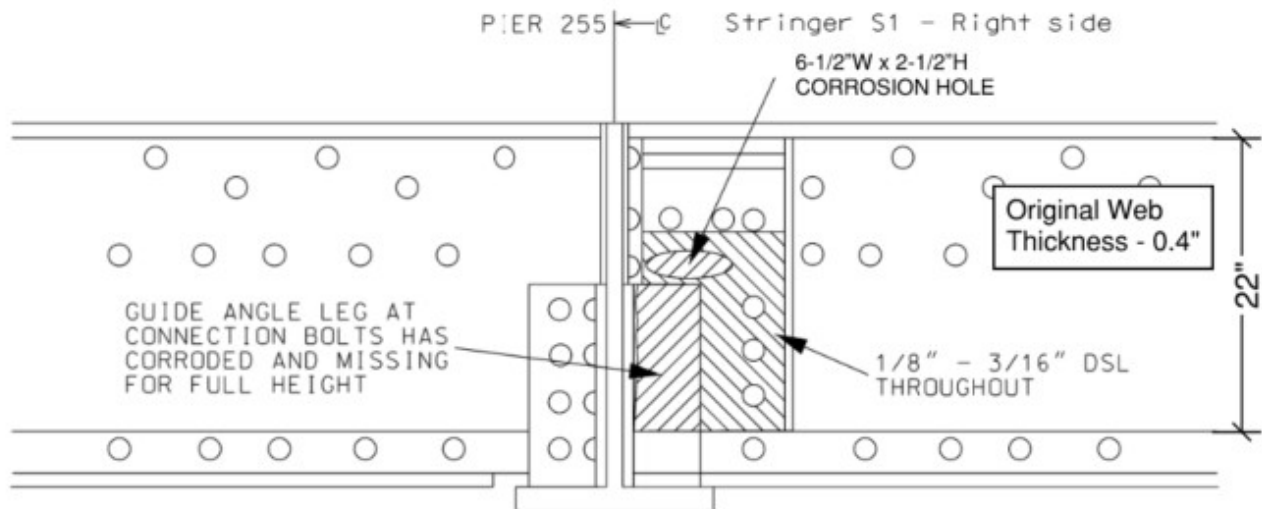
SPAN 256, STRINGER S1 AT PIER 255
(LOOKING LEFT)
N.T.S

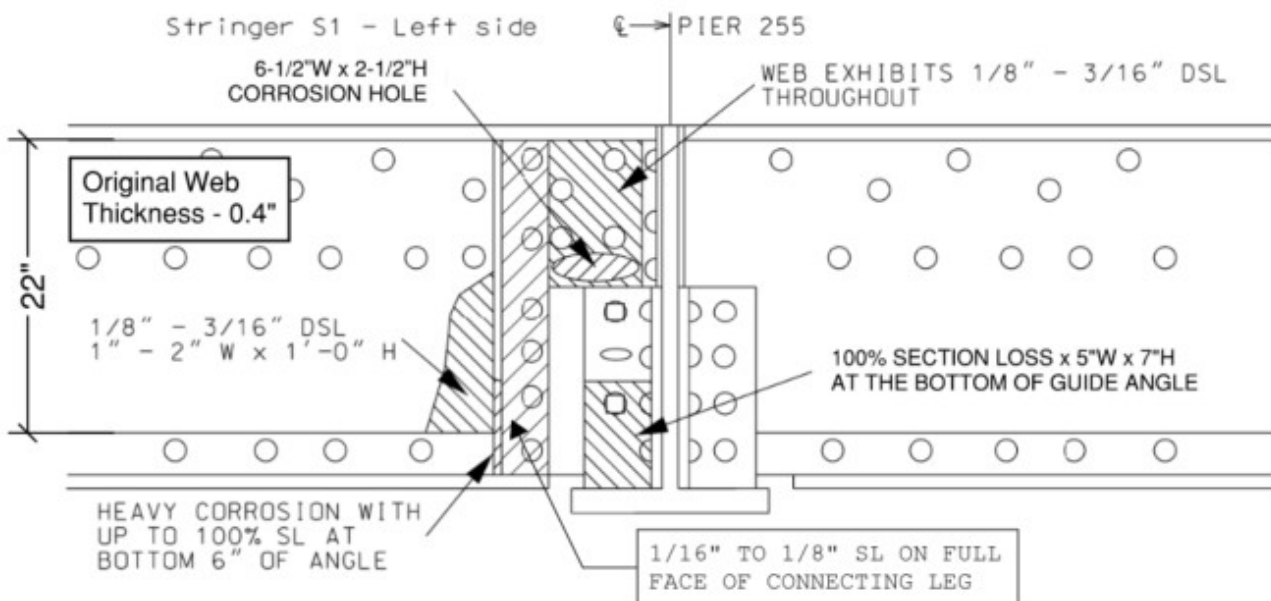
SKETCH FOR YELLOW # NB23U4W015
SPAN 256, STRINGER S1 AT PIER 255
(LOOKING RIGHT)
N.T.S

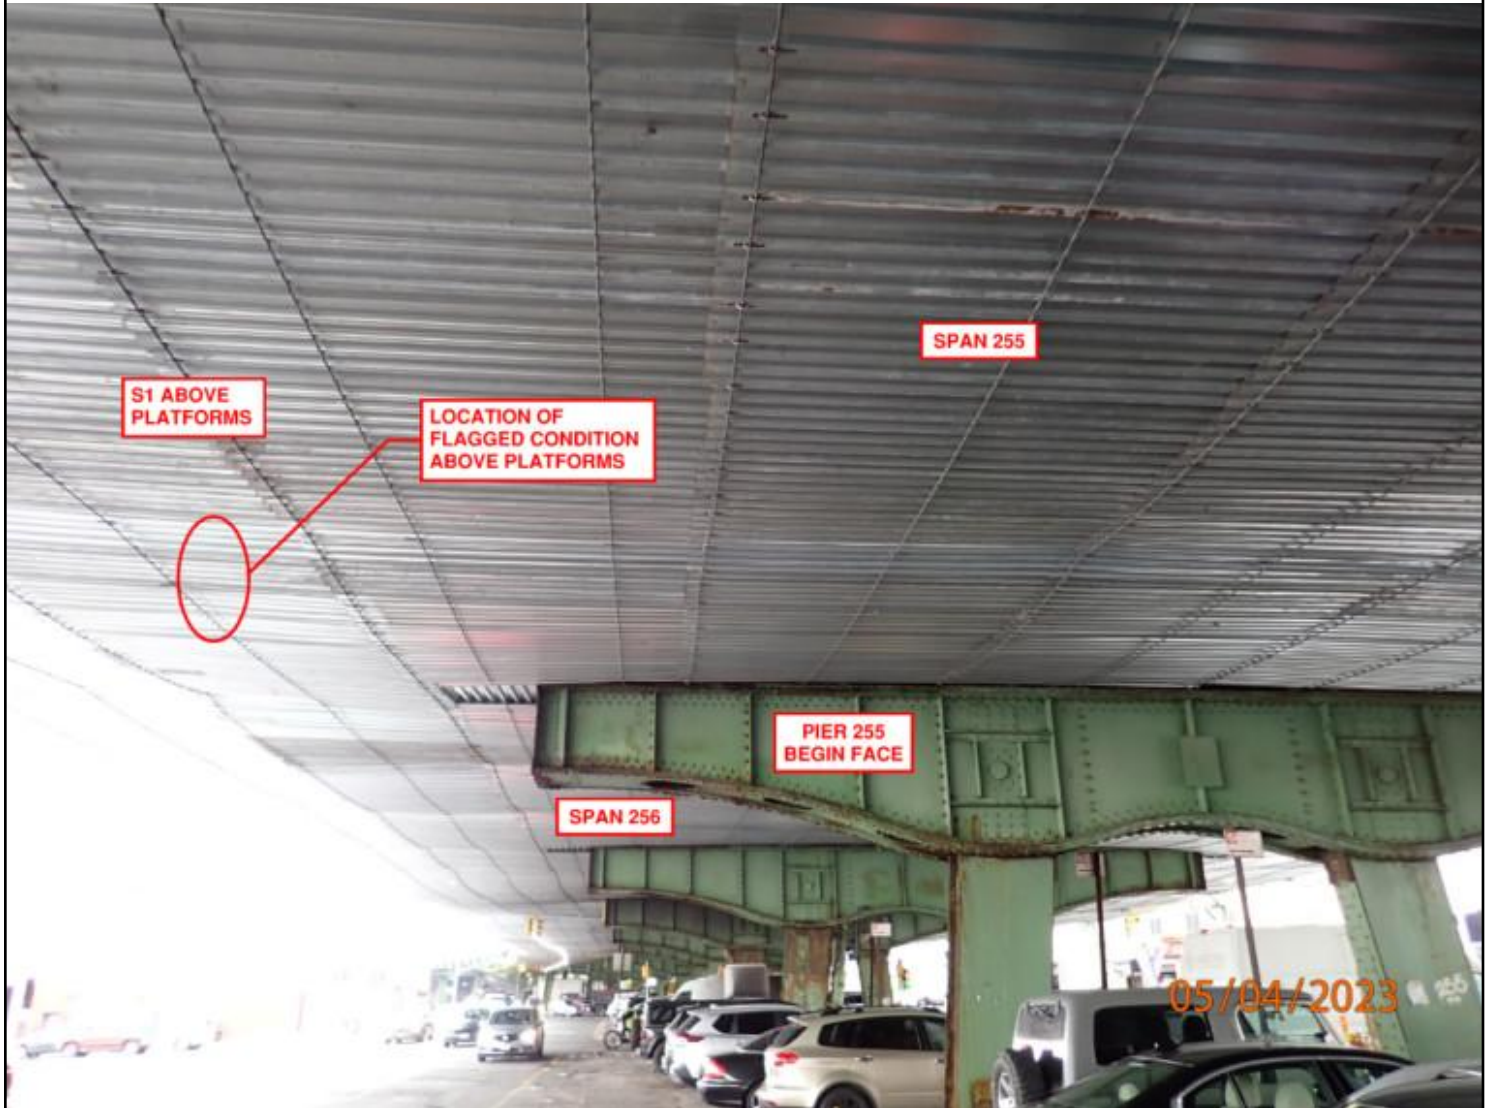
Photo Number: 3

Attachment Description: General View of Flag Location. Looking End

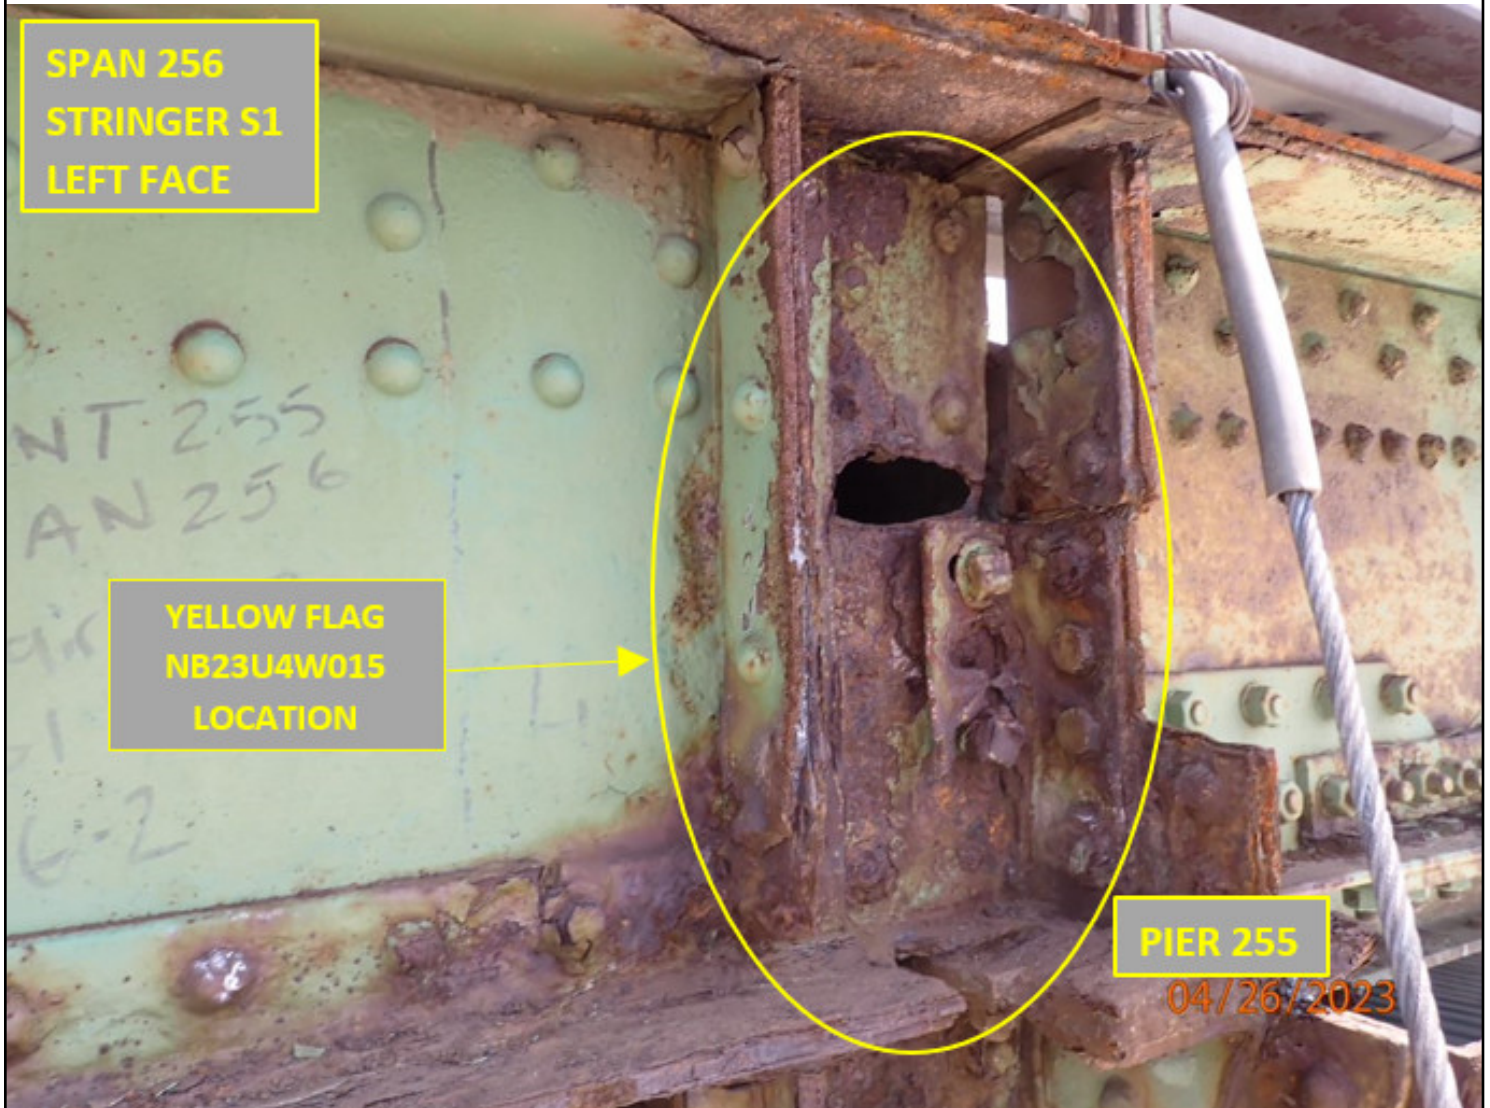
Photo Number: 4

Attachment Description: Span 256, Stringer S1 at Pier 255 Left Face. General view of the flagged location at pier cap connection. Looking Begin-Right.

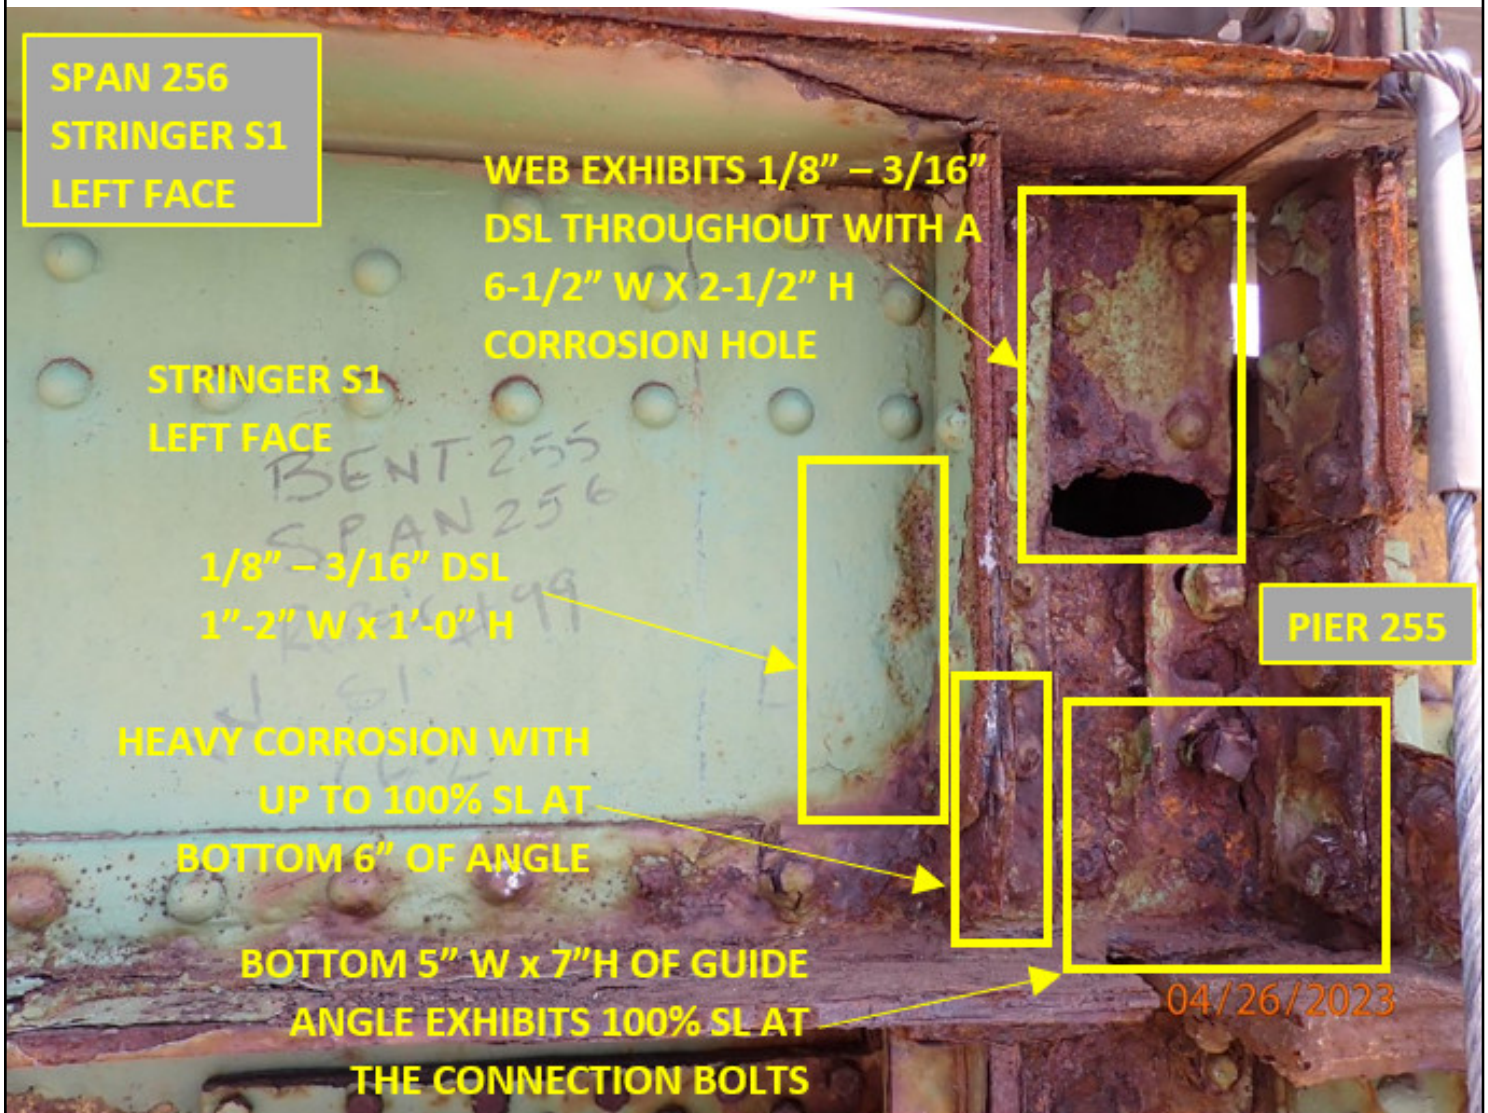
Photo Number: 5

Attachment Description: Span 256, Stringer S1 at Pier 255 Left Face. Close-up view of flagged location. Looking Right.

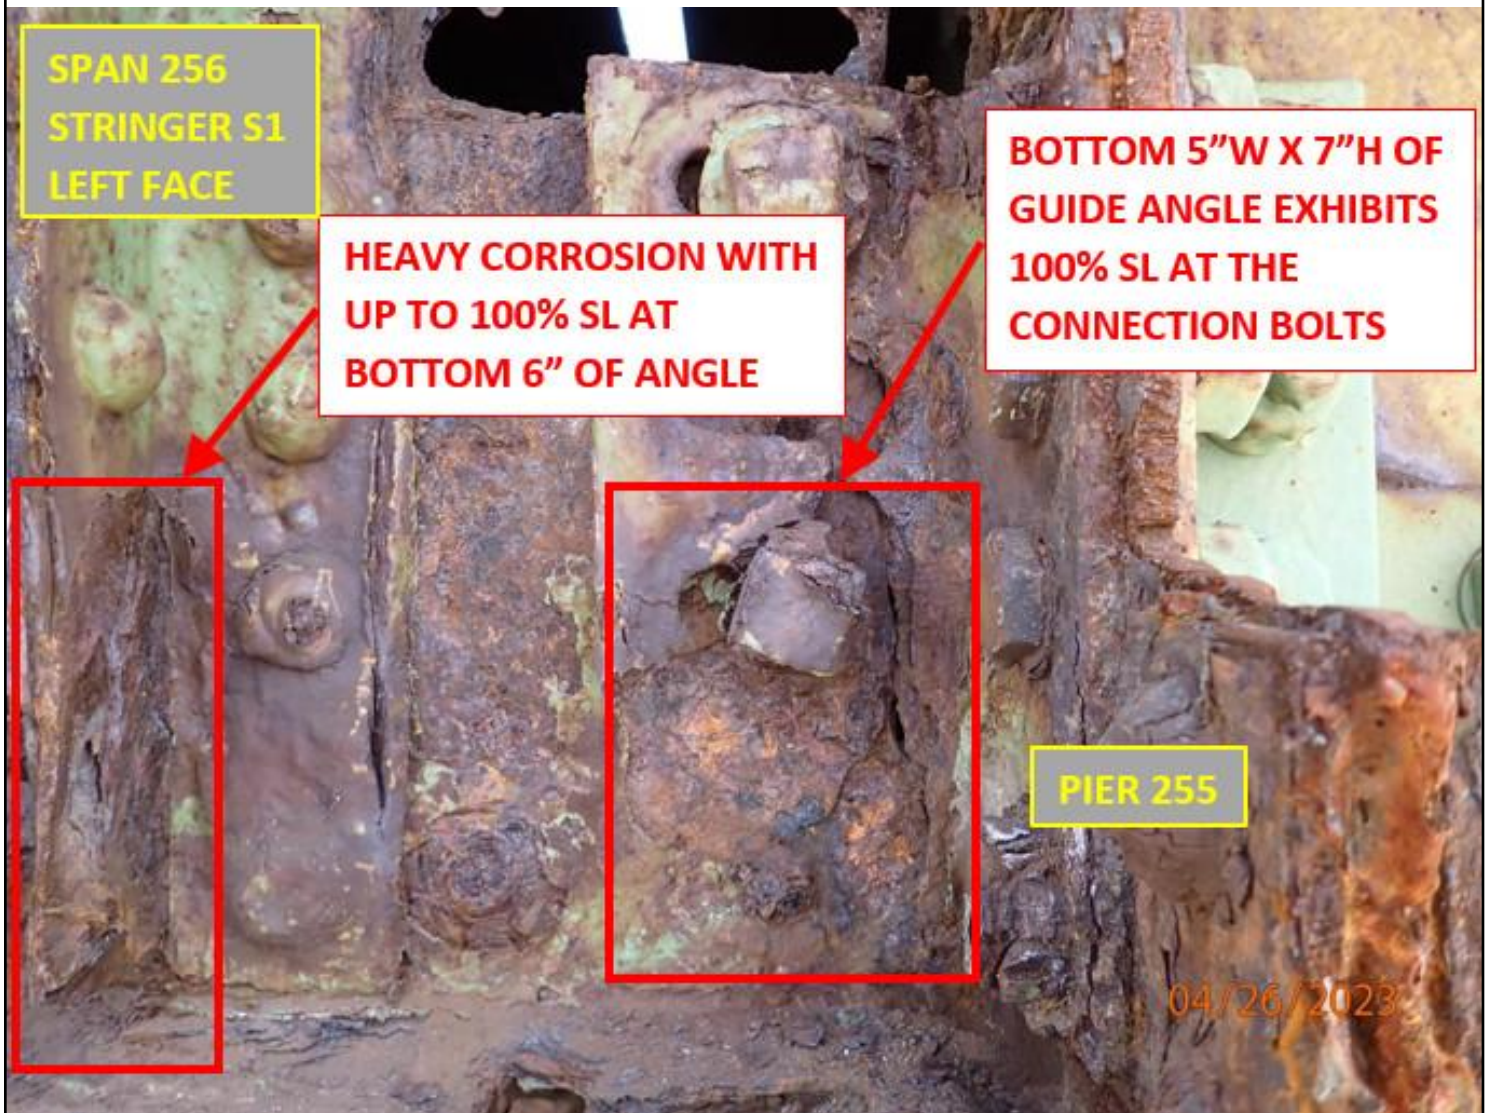
Photo Number: 6

Attachment Description: Span 256, Stringer S1 at Pier 255 Left Face. Close-up view of flagged location: Heavy corrosion with up to 100% section loss at bottom 6" of stiffener angle; and the bottom 5" W x 7"H of guide angle exhibits 100% section loss at the connection bolts. Looking Right.

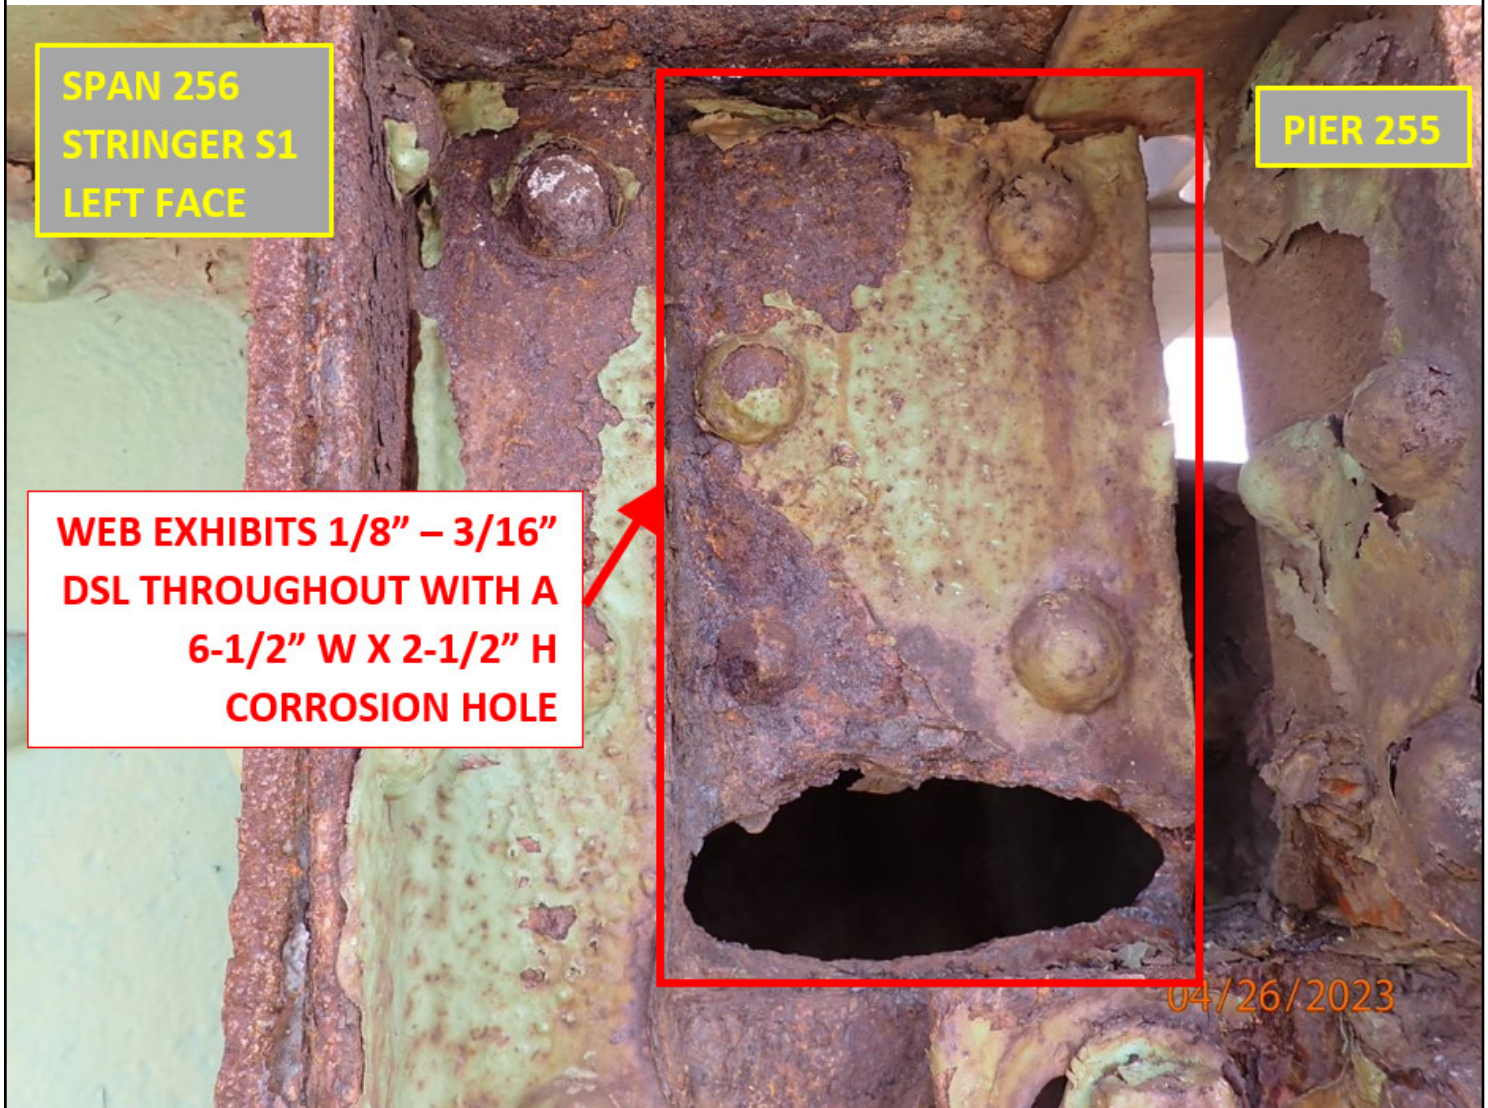
Photo Number: 7

The right face of the Stringer S1 (curb girder) in the upper web at the connection to Pier 255 exhibits a 6-1/2"W x 2-1/2"H corrosion hole. The web between the connection angle and the stiffener angle exhibits varying section loss from 1/8" to 3/16" (avg. 39%) deep section loss. The guide angle connecting leg at connection bolts has corroded completely and is missing for the full height. The left face of the stringer web also exhibits varying from 1/8" to 3/16" (avg. 39%) deep section loss throughout, between the connection angle and the stiffener angle.

Attachment Description: Span 256, Stringer S1 at Pier 255 Left Face. Close-up view of flagged location: Web exhibits 1/8" – 3/16" D section loss throughout with a 6-1/2" W x 2-1/2" H corrosion hole. Looking Right.

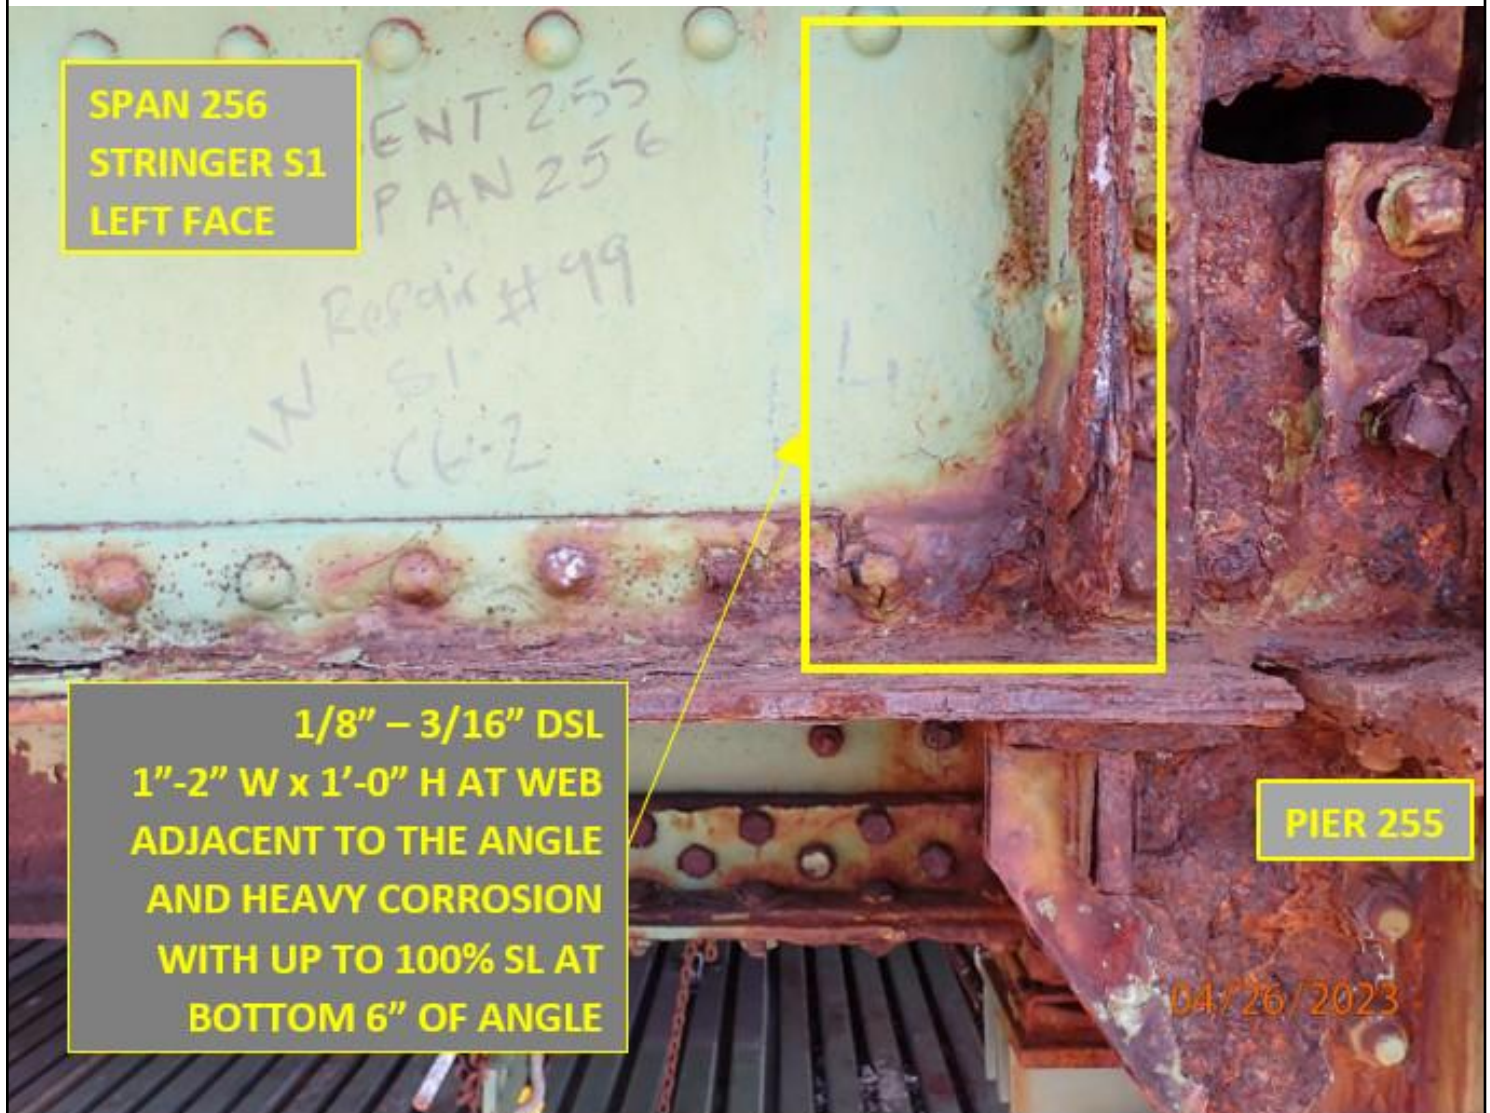
Photo Number: 8

Attachment Description: Span 256, Stringer S1 at Pier 255 Left Face. Close-up view of flagged location: 1/8" – 3/16" D section loss x 1"-2" W x 1'-0" H at web adjacent to the angle and heavy corrosion with up to 100% section loss at bottom 6" of the angle. Looking Right.

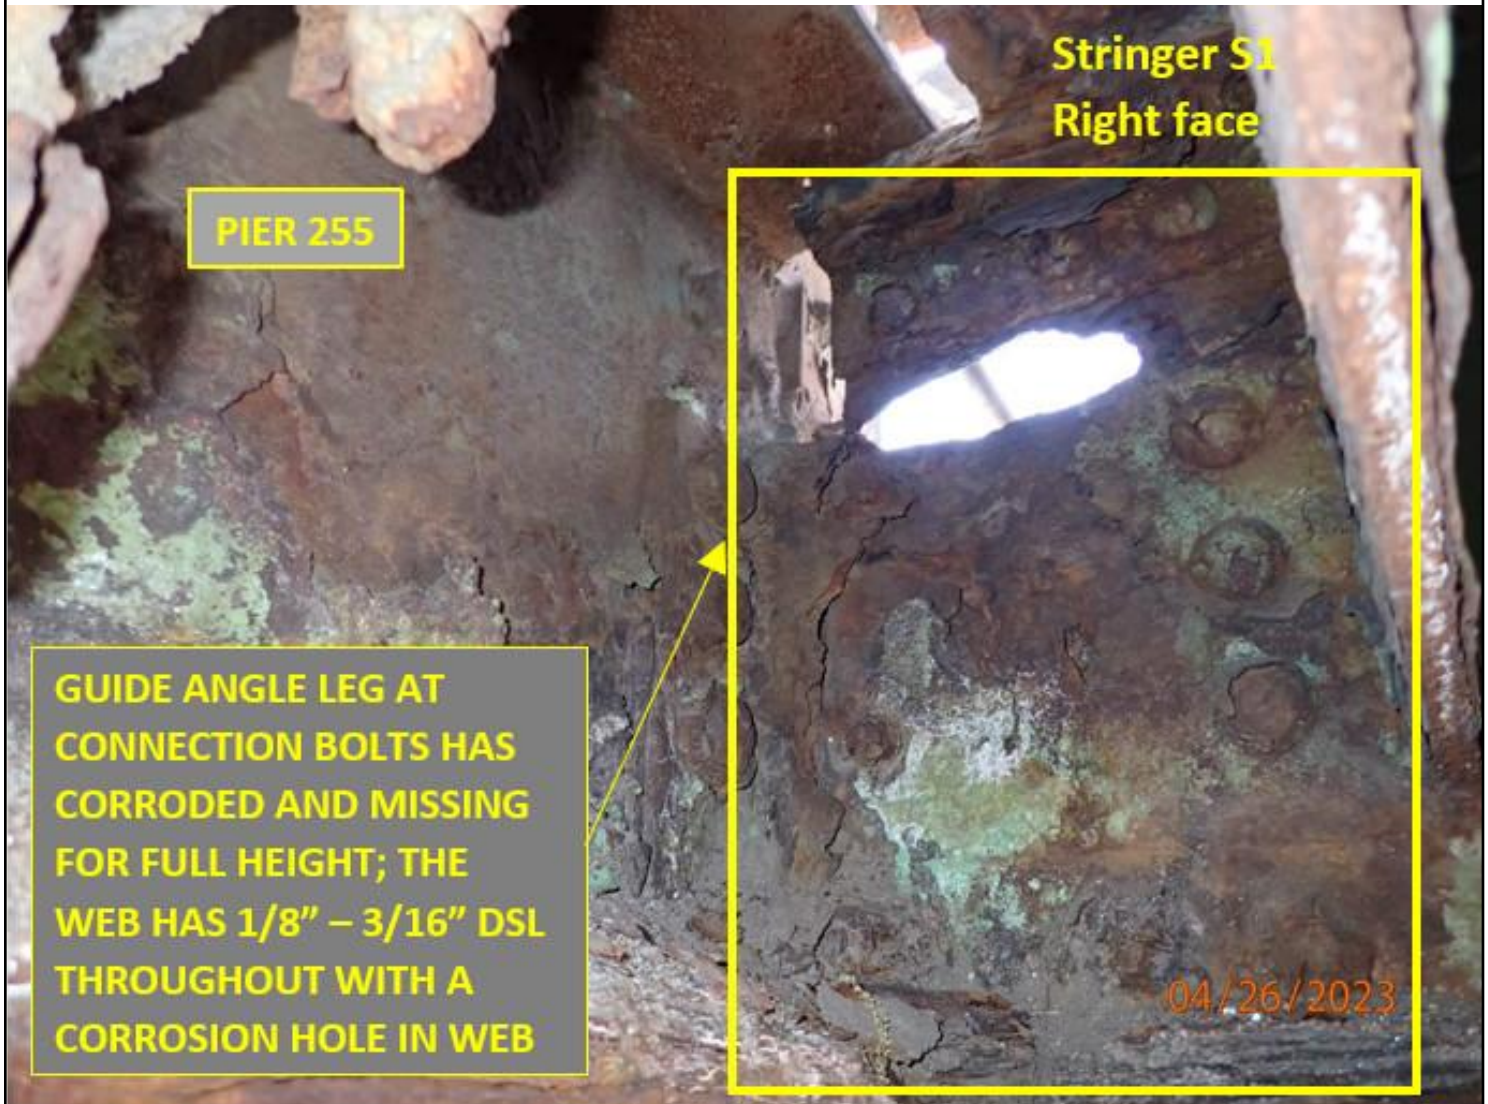
Photo Number: 9

Attachment Description: Span 256, Stringer S1 at Pier 255 Right Face. Guide angle leg at connection bolts has corroded and missing for full height; the web has 1/8" – 3/16" D section loss throughout with a 6-1/2" W x 2-1/2" H corrosion hole. Looking Begin-Left.
